# APPENDIX H

## Asset Management Plan

# Asset Management Plan 2024

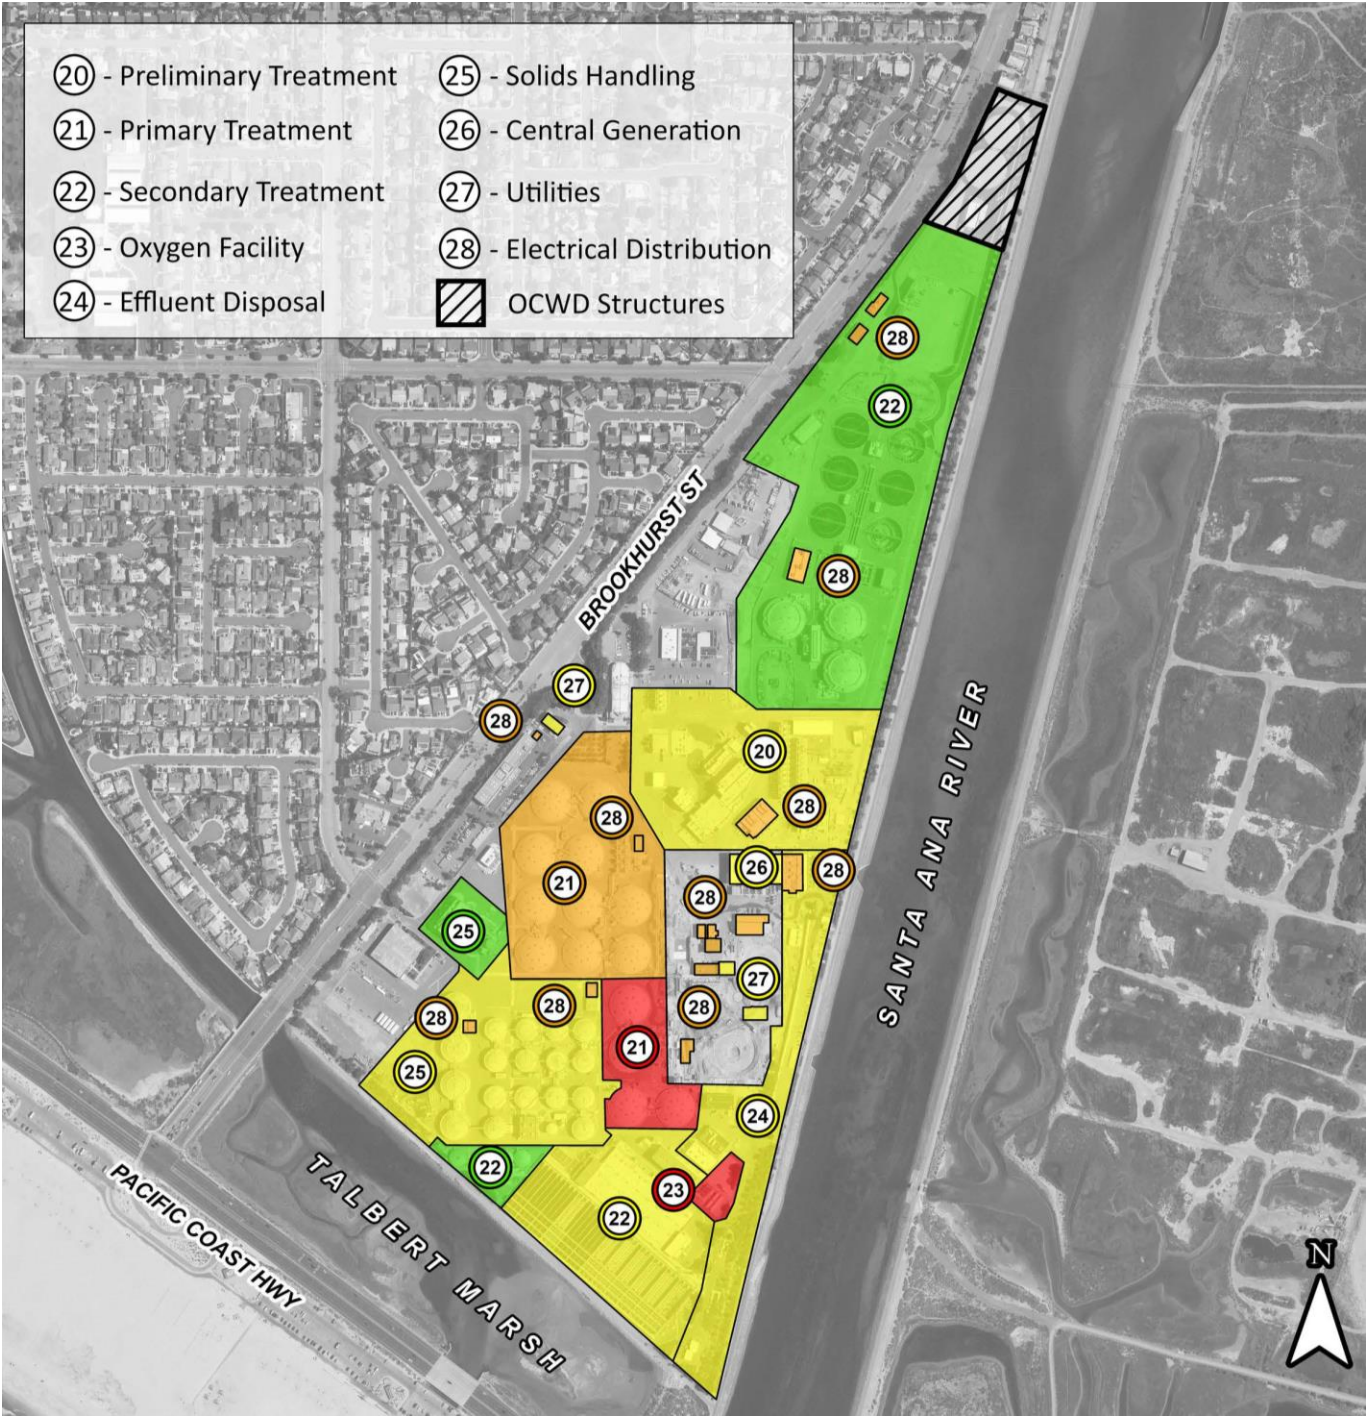
Figure ES-4. Plant No. 2 Process Area – Remaining Useful Life Score Map

Note: Area 29 is excluded from the map. The colored process areas reflect the average RUL score as shown on the respective table.

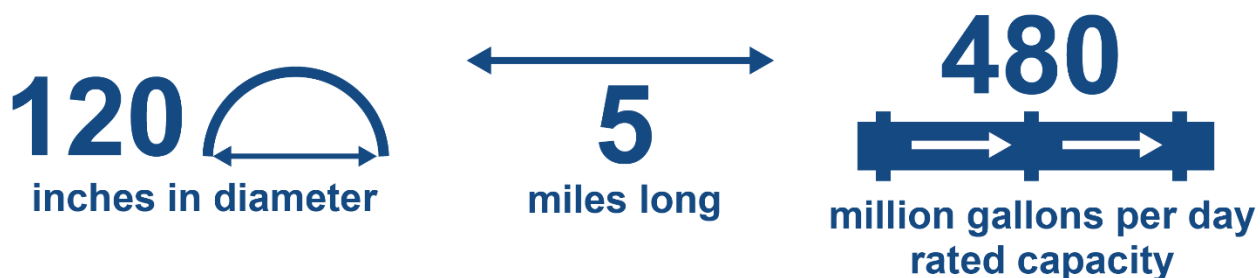
#### OUTFALL NO. 2 PRIMARY OCEAN OUTFALL

**Outfall No. 2** serves as the primary ocean outfall, discharging treated wastewater approximately 5 miles offshore at a depth of approximately 200 feet. It began service in 1971. Based on the findings of a comprehensive assessment study completed in 2022, a rehabilitation project is in progress to ensure the outfall's reliability for many years to come.

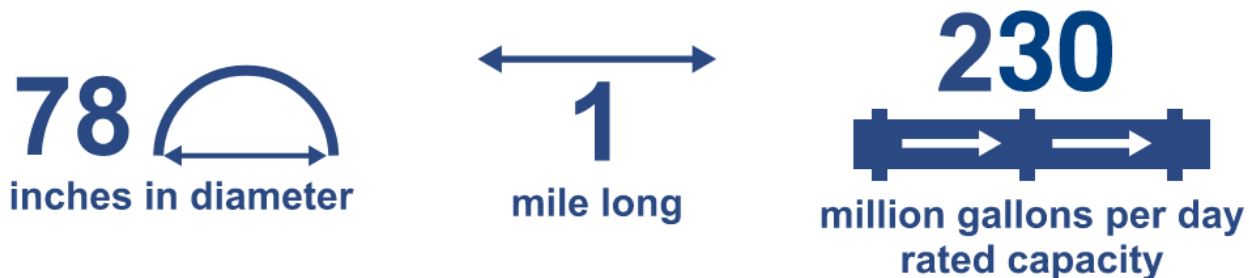
#### OUTFALL NO. 1 EMERGENCY OUTFALL

**Outfall No. 1** serves as an emergency outfall and primary backup to Outfall No. 2, discharging treated wastewater over a mile offshore at a depth of approximately 65 feet. It was originally constructed in 1954 and was later modified in 1965. OC San's NPDES permit specifies that this outfall can be used only in the case of an emergency or during planned maintenance activities.

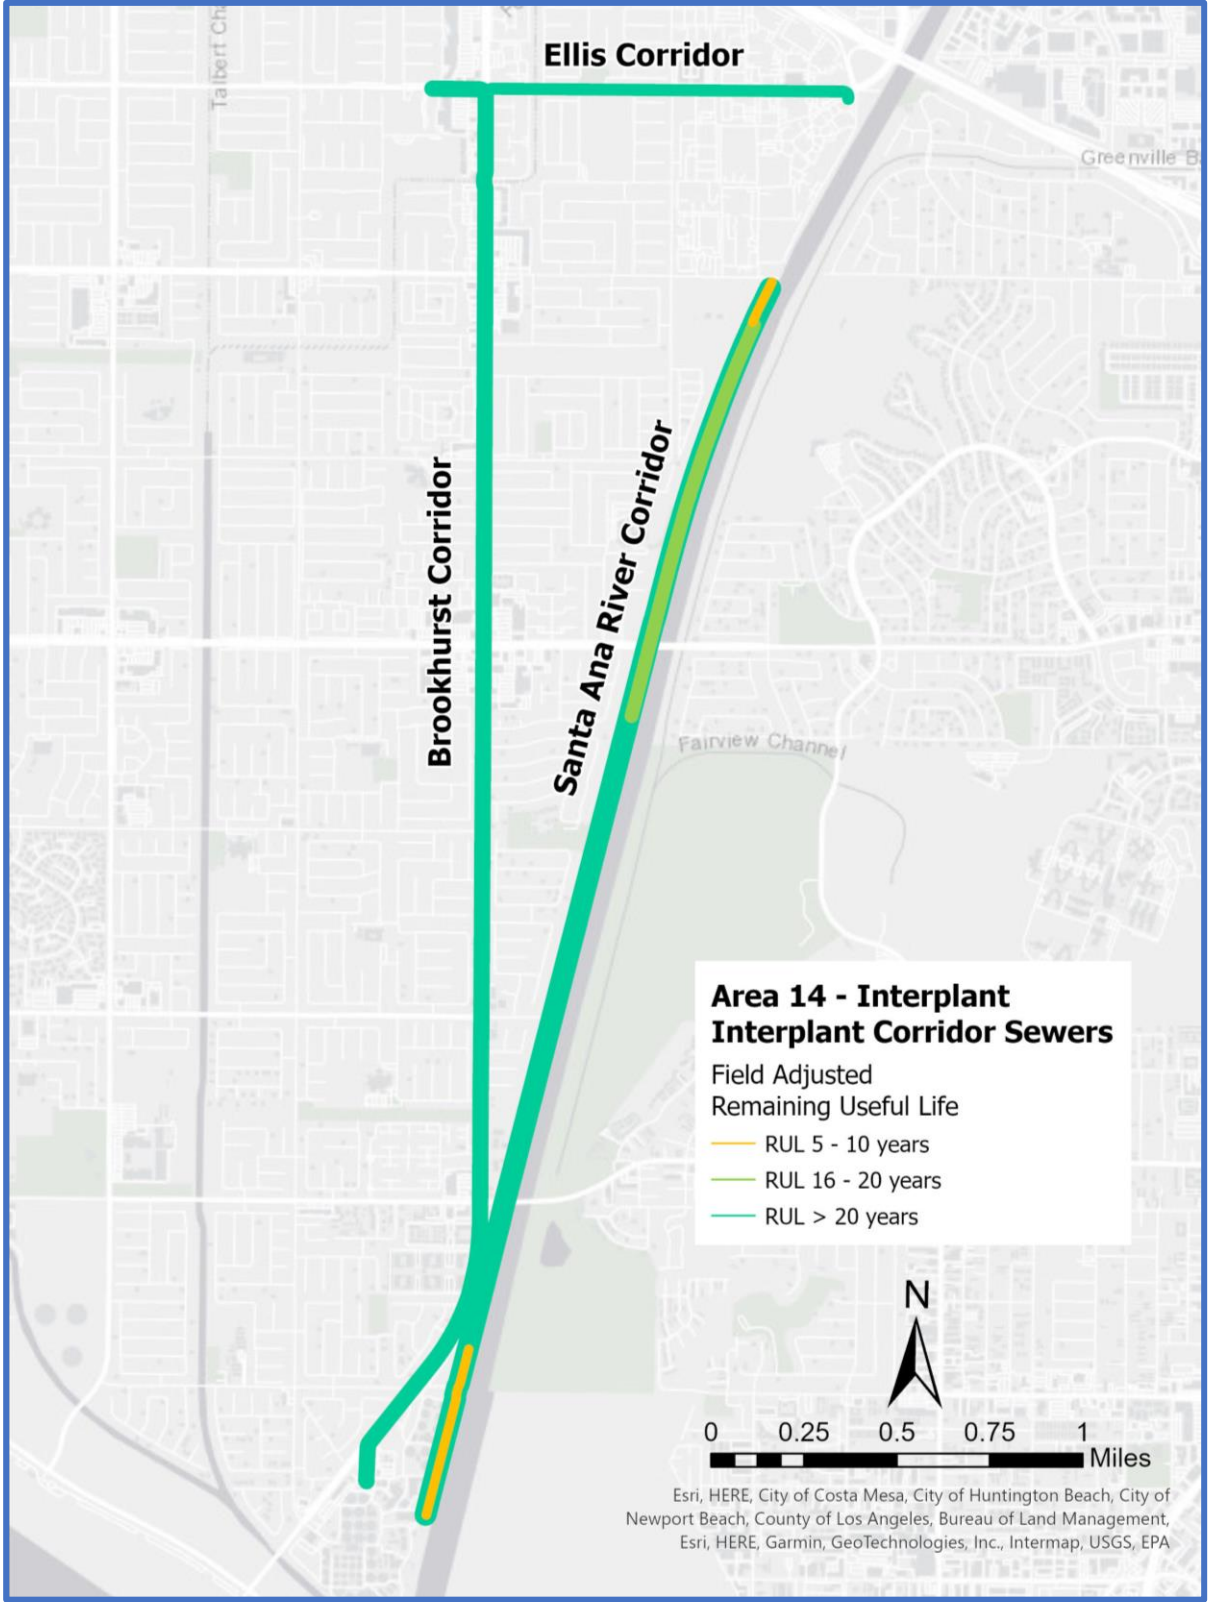
Remaining Useful Life Maps

AREA 14 ASSET MANAGEMENT SUMMARY – PLANT NO. 1 INTERPLANT

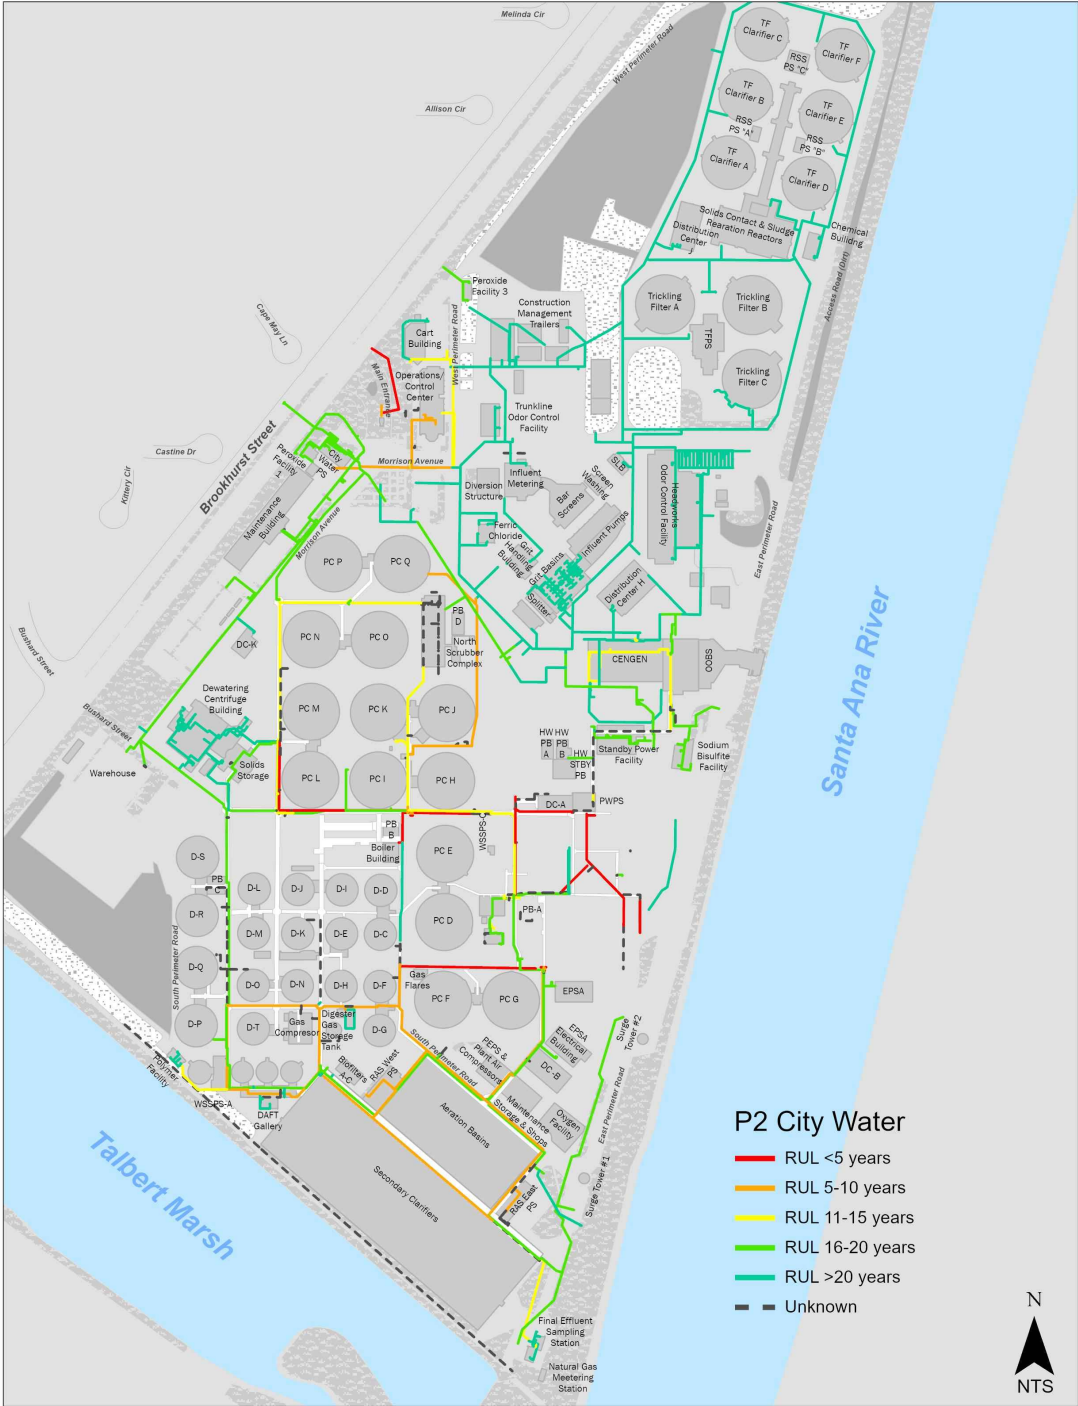
Remaining Useful Life of Utility Infrastructure

AREA 27 ASSET MANAGEMENT SUMMARY – PLANT NO. 2 UTILITIES
